MEMORIAL HALL THE NEXT GENERATION OF REFURBISHMENT

...a landmark project in the heart of Southbridge

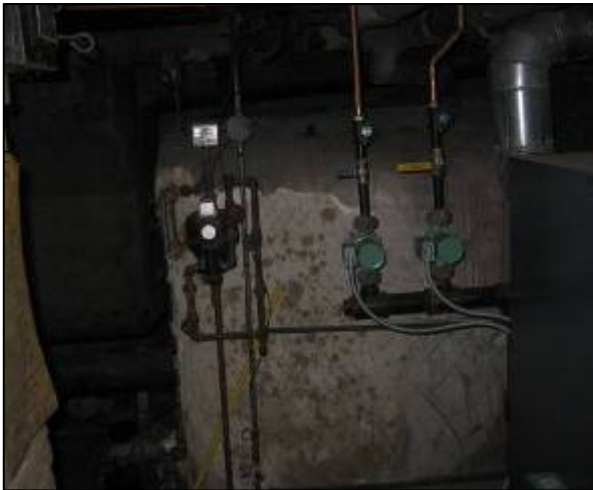
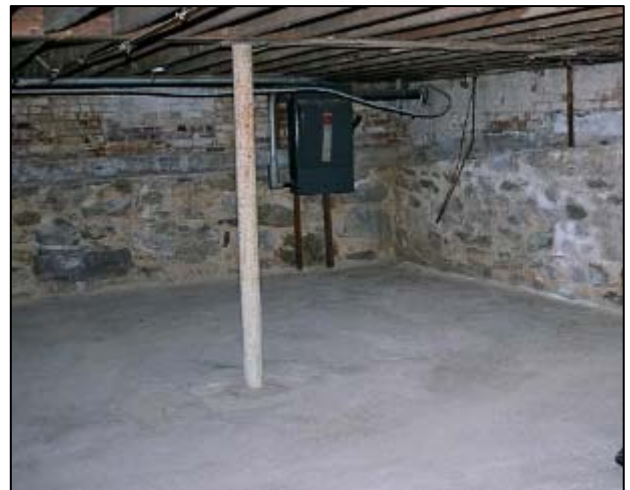
A contractor was hired to identify and safely remove all hazardous materials in the building. Significant amounts of asbestos were removed from the original heating system boiler, piping and floor tiles.

Once removed the basement areas were cleaned and certified free of hazardous materials.

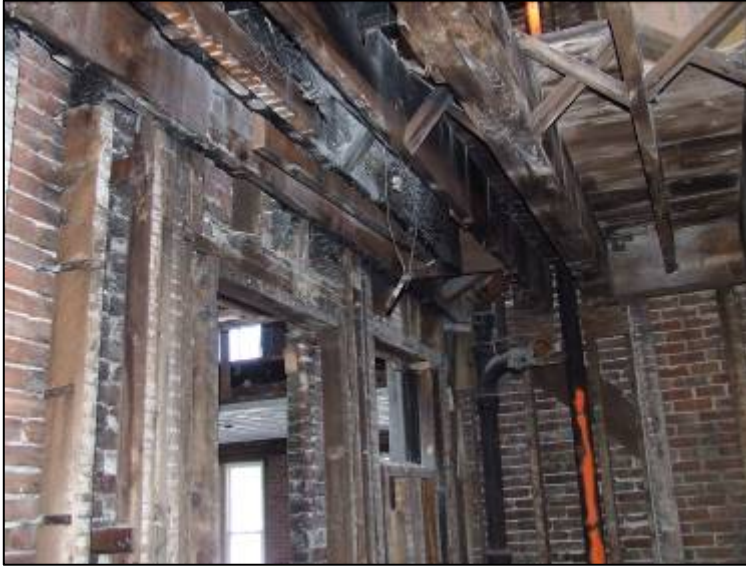
The stripped back walls revealed that the building has survived fire in the past. We don't know when it occurred but it was suppressed and the structure repaired by inserting steel beams into the walls. The fire was quite localized and while it was suggested that fire may have forced the removal of the pitched roof, it is unlikely that this was the fire.

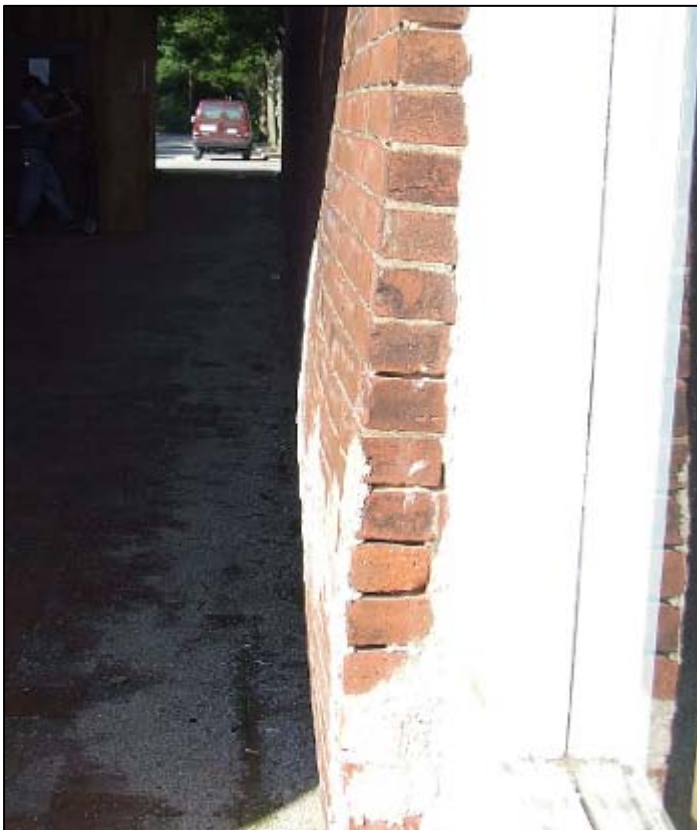
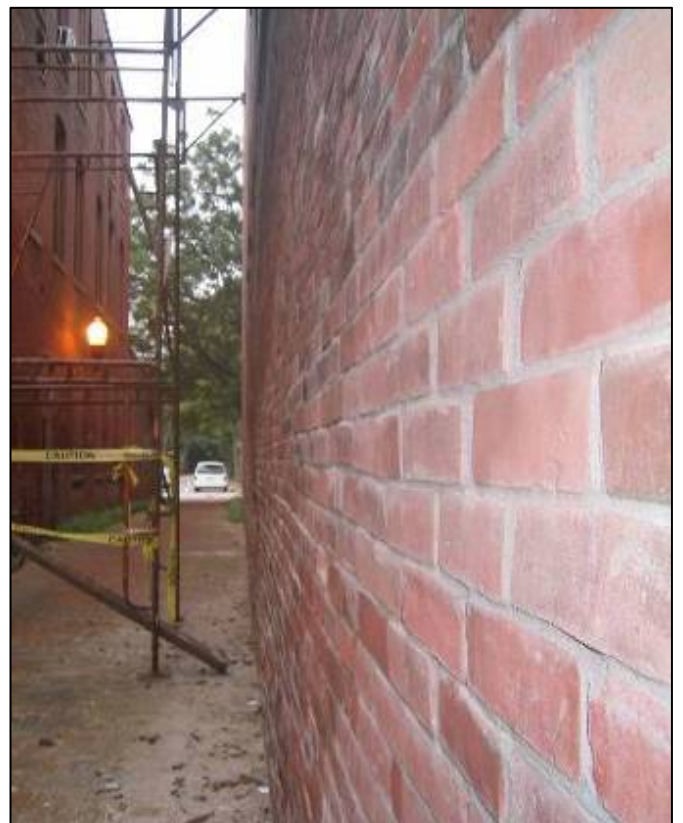
The open walls did not reveal any significant structural faults in the building fabric. One area where significant need for work was required was found on the ground floor.

This was not unexpected, as can be seen in the photograph above, where the wall is clearly bulging out into the alleyway. With access available via the inner and outer side of the wall it was possible to repair the fabric.

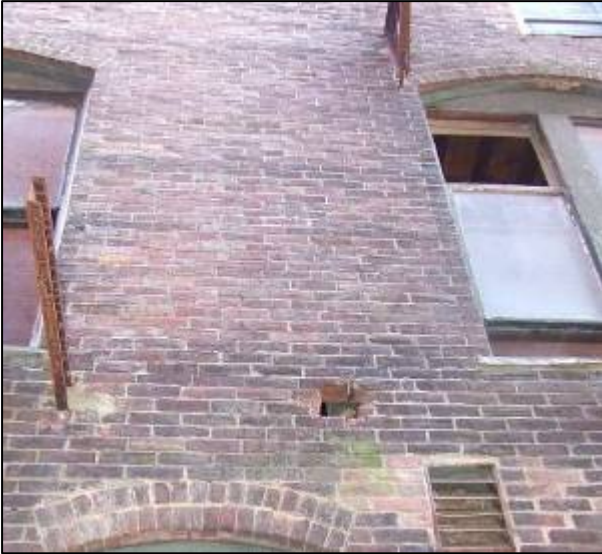
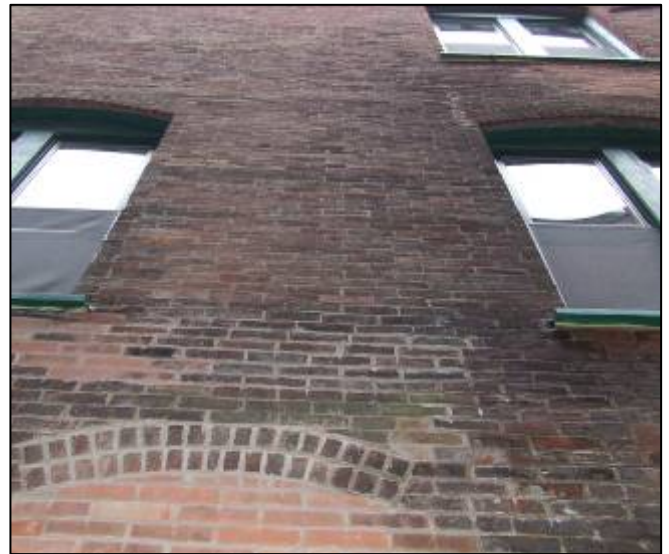
The above photographs show how the remaining fire escape rails were removed and the holes repaired. In the refurbished building it is planned to add additional doors to facilitate the need for multiple egress paths from the building. A number of vents and small arches were also filled during this process.

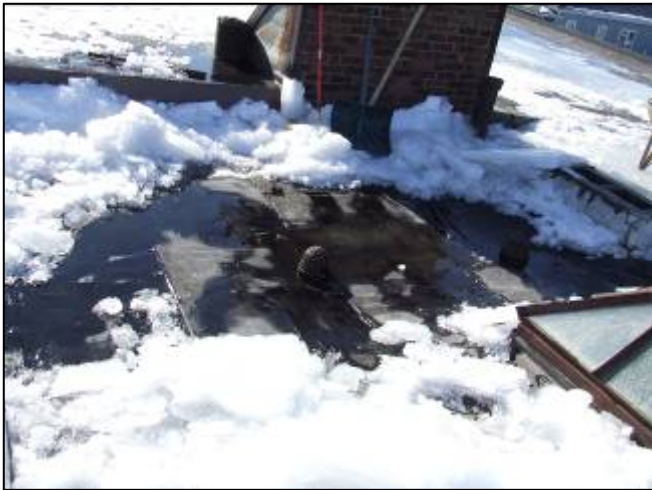
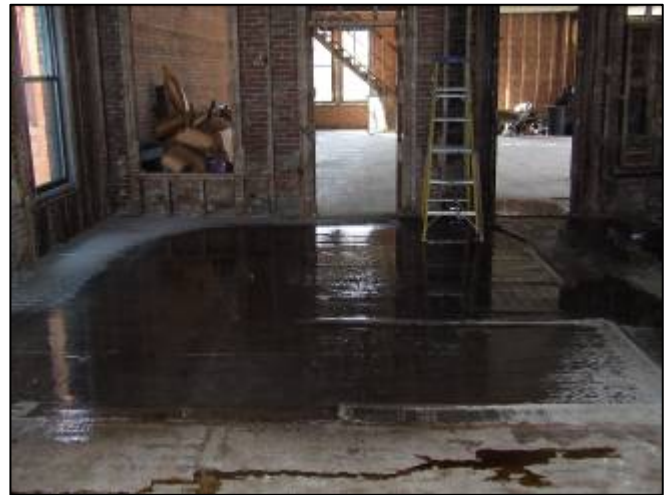
During the spring thaw the work was halted and the building cold. This allowed ice to build up on the rainwater drains on the roof. Once blocked, water built up on the roof and finally overflowed the glass roof hatch and entered the building.

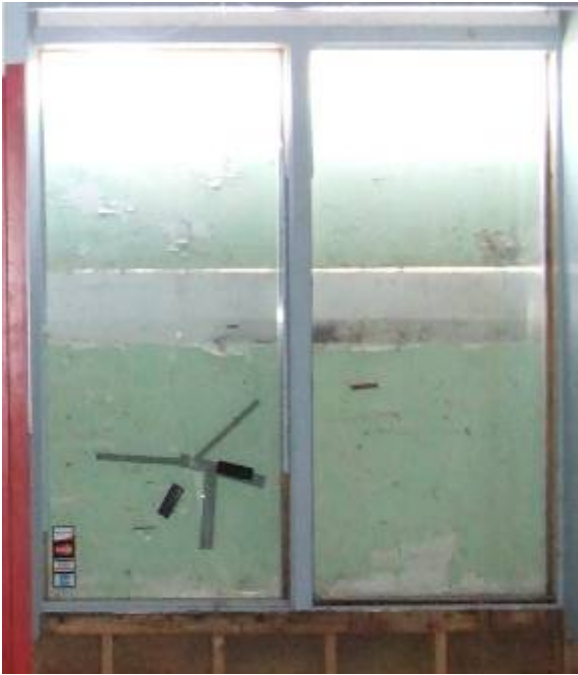
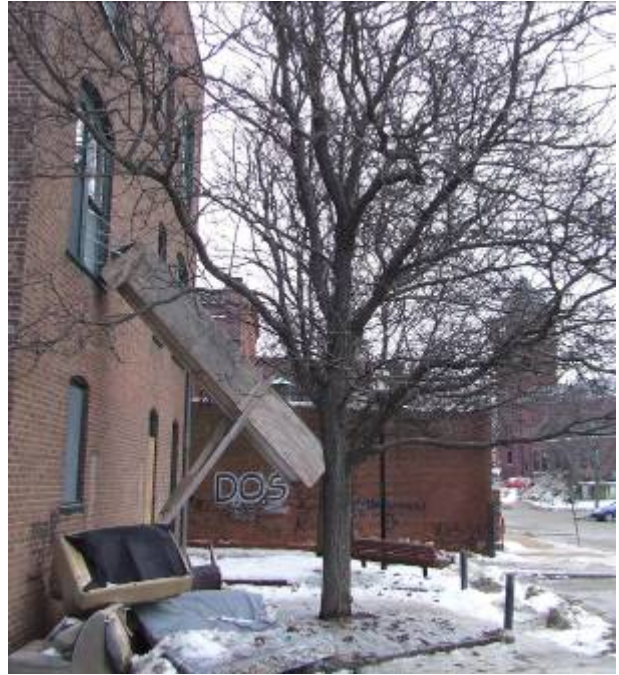
Other problems that seem to arise with projects such as ours are vandalism and dumping on site. We continue to pick up abandoned furniture items and repair glass.
