MEMORIAL HALL THE NEXT GENERATION OF REFURBISHMENT

...a landmark project in the heart of Southbridge

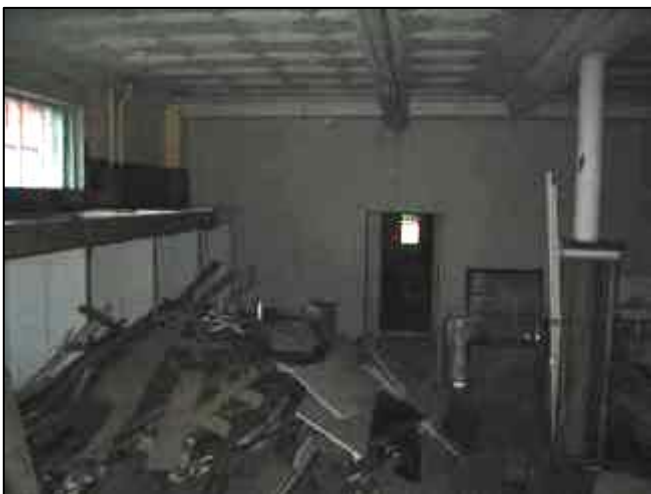
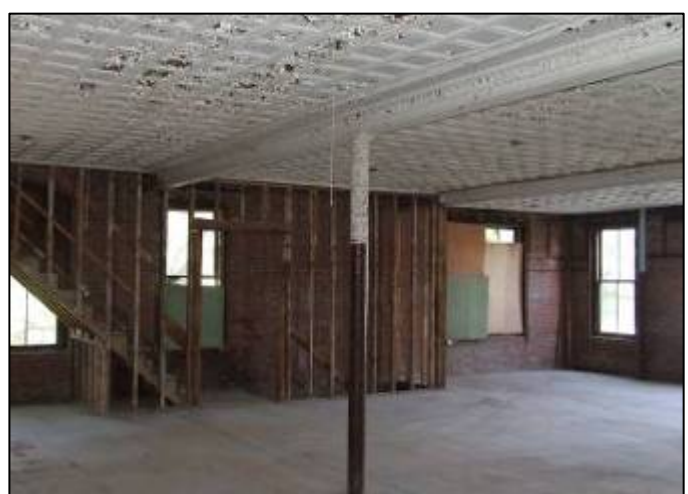
waste material that was being “stored” around the building. The walls were also stripped back to remove any traces of hazardous materials such as lead paint and asbestos.

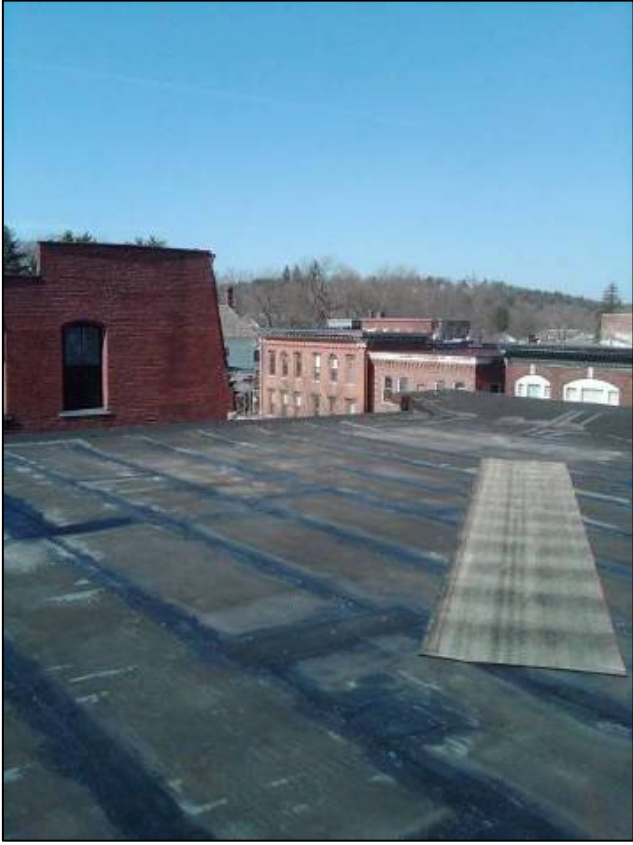
During the spring thaw the work was halted and the building cold. This allowed ice to build up on the rainwater drains on the roof. Once blocked, water built up on the roof and finally overflowed the glass roof hatch and entered the building.
